PHASE I INSPECTION REPORT
NATIONAL DAM SAFETY PROGRAM

Name of Dam Kagley
County Blount
Stream Unnamed Trib. of
Sixmile Creek
Date of Inspection May 19, 1981

PHASE I INSPECTION REPORT
NATIONAL DAM SAFETY PROGRAM
KAGLEY DAM
BLOUNT COUNTY, TENNESSEE

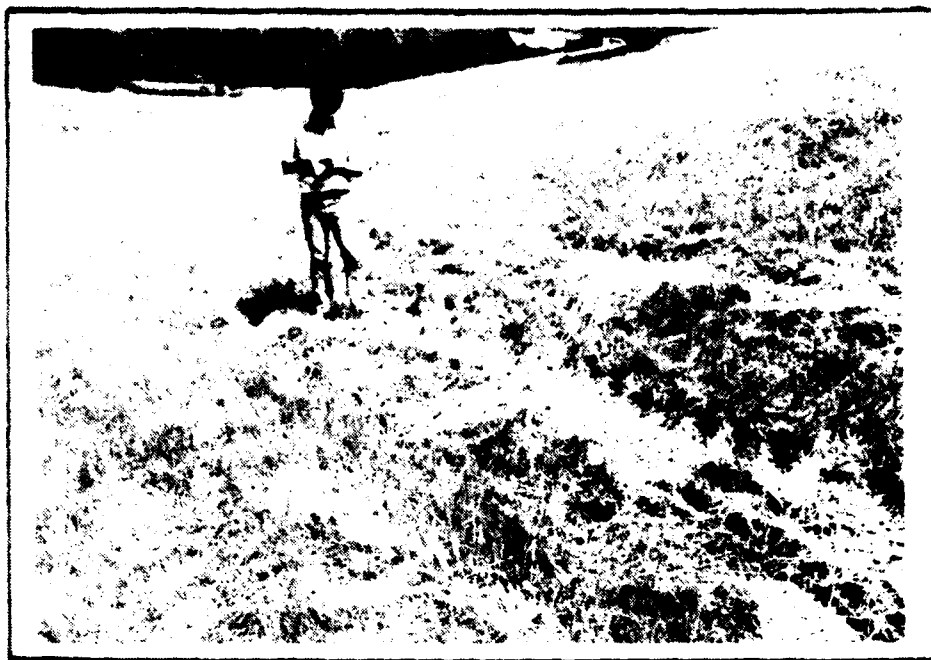
PHOTO NO .11

The downstream face has a gradual transition with each abutment giving the appearance of a "bowl" shape. The downstream slope was found to have a good cover of well maintained grass on a fairly uniform continuous grade of 1V:3.5H (photo 3). There are three 4 inch diameter pine trees evenly spaced on the slope a few feet below the crest (photo 4). Near the middle of the dam and approximately halfway down the slope a soft area, roughly 5' X 20', was observed with wetland vegetation (photos 10 & 11). A rut roughly 10 feet long and 3 inches deep was located down from the soft area near the toe (photos 10 & 11). There was no evidence of seepage from either area.

- Photo No. 11 - Soft area.
- Photo No. 12 - Erosion rut.
- Photo No. 13 - Erosion hole from break in spillway pipe.
- Photo No. 14 - Break in service spillway pipe. Note water
supply pipe location.

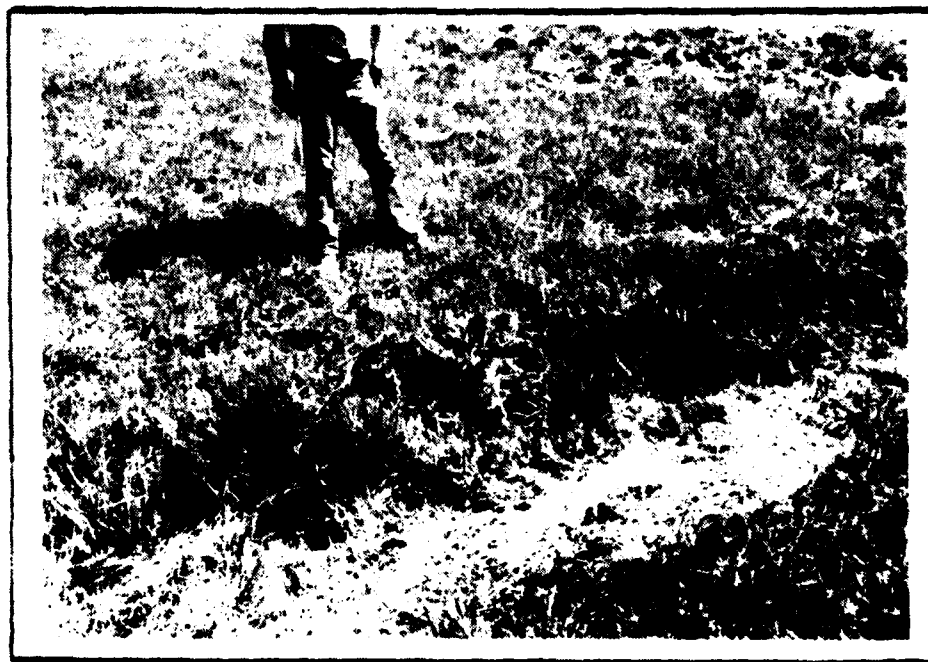
PHOTO NO .12

2. Sloughing, Subsidence, or Depressions; Abnormal
Bulges or Non-Uniformity About 1/3 way from left
abutment near toe, apprx. 10' long roughly 2'
wide rut
3. Surface Cracks on Face of Slope None found
4. Surface Cracks or Evidence of Heaving at
Embankment Toe None found
5. Wet or Saturated Areas or Other Evidence of Seepage
on Face of Slope; Evidence of "Piping" or "Boils"
Soft area w/ wetland vegetation 1/4 way from left
abutment roughly 10' above toe.
6. Drainage System None found
7. Fill Contact with Outlet Structure None found
8. Condition of Grass Slope Protection Good
